Final Research Report

Research for the Development of Best Management Practices to Minimize Horse Trail Impacts on the Hoosier National Forest

Virginia Tech

March 2005

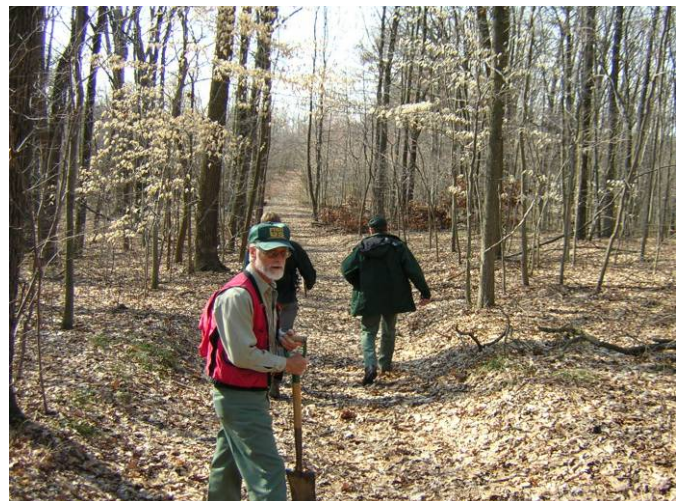
Figure 2. Horse trail developed along a former skid trail on the Hoosier NF.

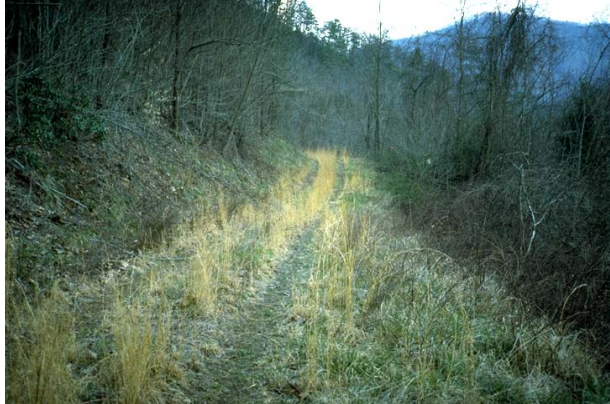
Figure 4. View of one road evaluated by Swift (1984) after the road has been stabilized with gravel and vegetation.

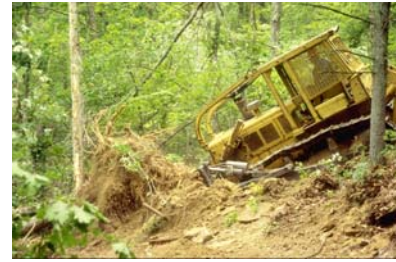
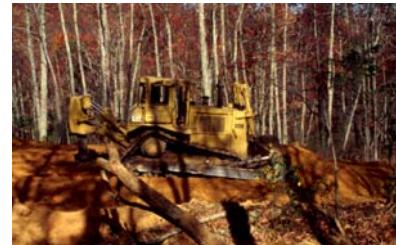
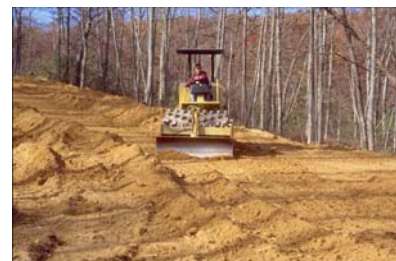
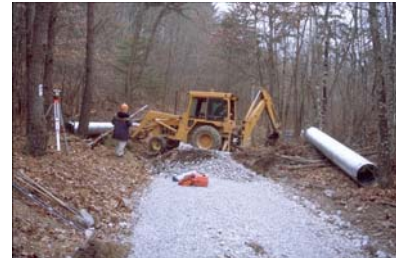
Figure 5. From top to bottom: typical examples of trail clearing, establishment of road surface, stabilizing the surface, installation of water control/stream crossing structures, and surfacing.

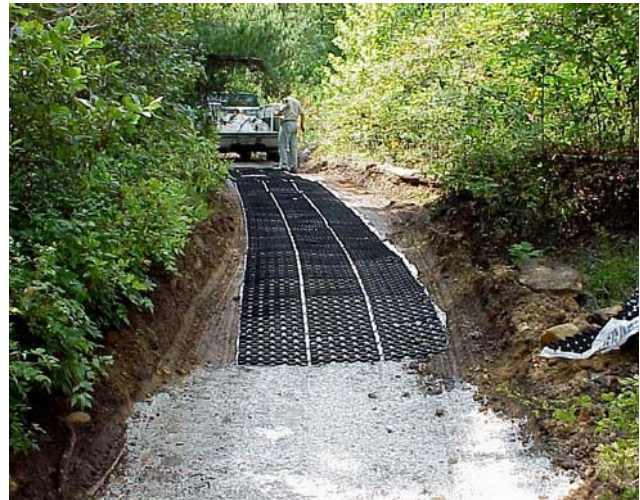
Figure 7. Applying geosynthetics to a horse trail in the Daniel Boone NF.

Geosynthetics are particularly effective in increasing the trafficability of treads in wet soils (Meyer 2002). Due to their tensile strength and/or rigidity, these materials increase the substrate's load bearing capacity by distributing loads over a larger area (Meyer 2002). Geosynthetics are also available for limiting erosion on steep slopes, though none were found that are specifically designed or recommended for supporting trail traffic. Two-dimensional natural fiber and synthetic mats can be applied over soil to retard erosion and enhance vegetative growth. Three-dimensional geosynthetics can be filled with soil or gravel to stabilize and

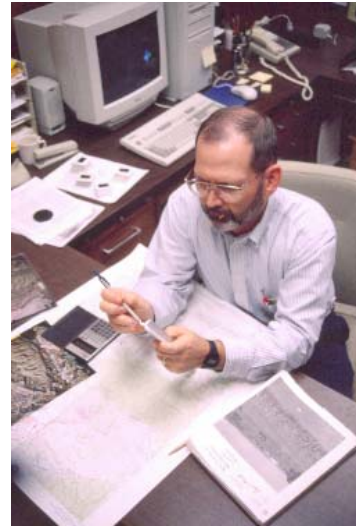
Figure 18. Common tools for office reconnaissance of forest trails include topographic maps, soil surveys, aerial photographs, dividers, scale, and calculator.

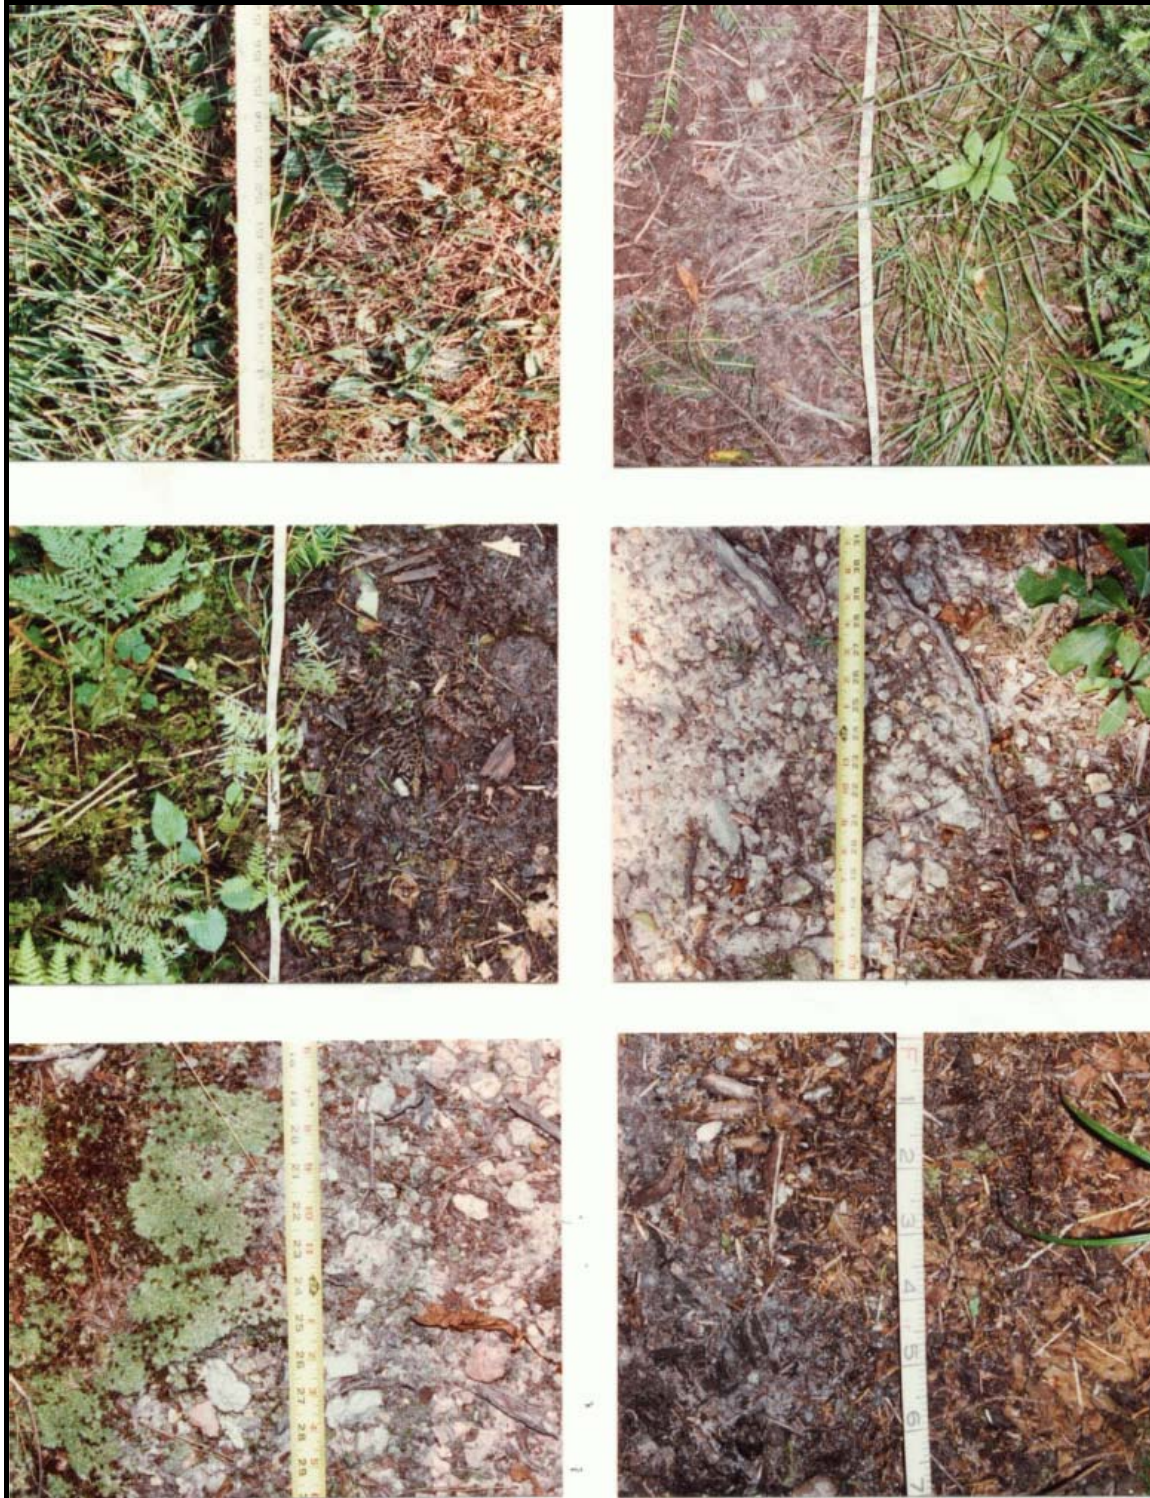
Figure 1. Photographs illustrating different types of boundary determinations. Trail tread boundaries are defined as the most pronounced outer boundary of visually obvious human disturbance created by trail use (not trail maintenance like vegetation clearing). These boundaries are defined as pronounced changes in ground vegetation height (trampled vs. untrampled), cover, composition, or, when vegetation cover is reduced or absent, as pronounced changes in organic litter (intact vs. pulverized). The objective is to define the trail tread that receives the majority (>80%) of traffic, selecting the most visually obvious boundary that can be most consistently identified by you and future trail surveyors.
